A Revised Beef Cattle Feeding Hoop Barn

RFR-A1894

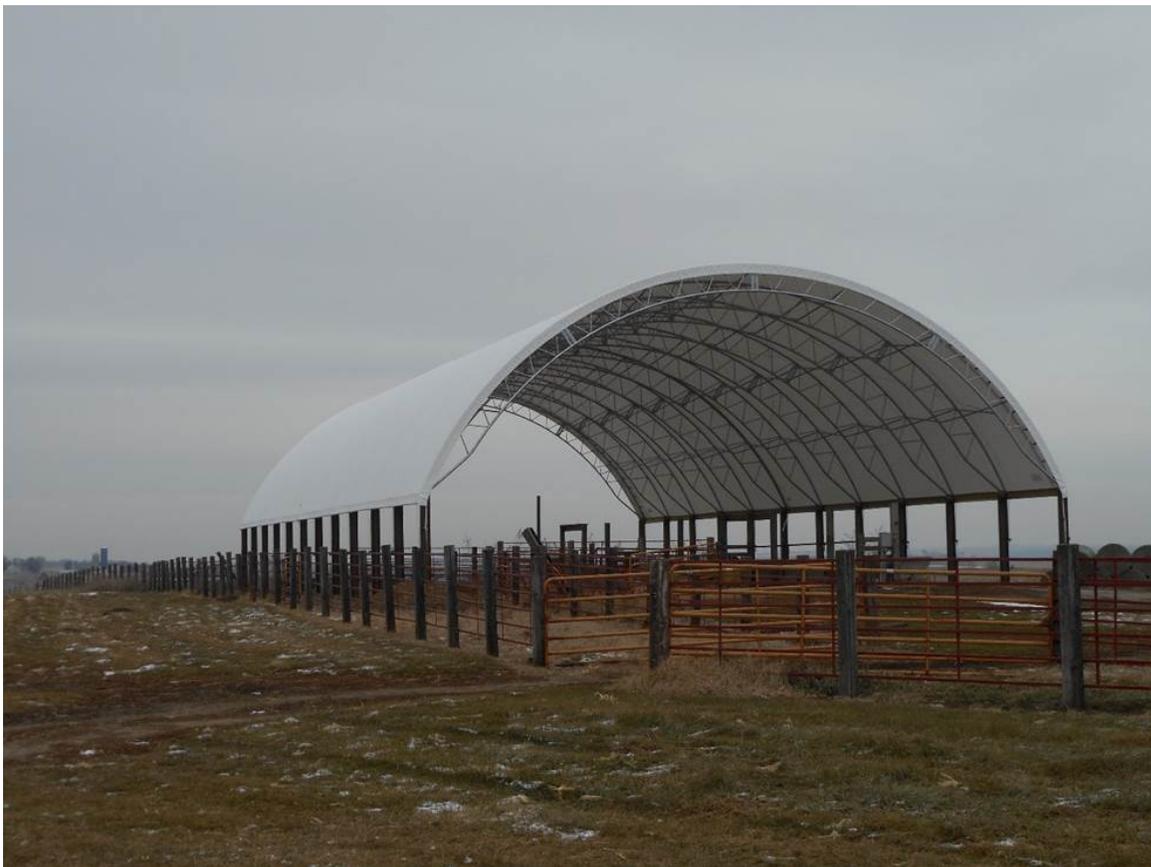
Figure 1. The revised hoop barn (68 ft x 132 ft) for cattle feeding (not fully finished).

In fall of 2018 a new hoop barn (Span-Tech, Inc.) was constructed on the site (Figure 1). The existing concrete floor and fenceline bunk were used. The new barn was 68 ft x 132 ft. The larger hoop barn was longer to allow space to set the new posts and was wider to provide room for the drive alley under the hoop and eliminate the need for an awning and gutter. The primary changes were 1) no ridge vent, 2) a concrete west wall about 6 ft tall with no gate openings, 3) the feeding alley under the hoop structure and no awning, 4) steel I-beam support posts with 9 ft walls,

5) a curtain above the concrete west wall, and
6) access to pens through gates in the pens only for sorting and bedding. A bale processor with blower will be used to bed the pens with cornstalks.
