# **UHPC Joint Fill Construction Problems and Solutions on the Pulaski Skyway**

Michael D. McDonagh, P.E., P.Eng., WSP USA  
Andrew J. Foden, Ph.D., P.E., WSP USA

The redecking of the Pulaski Skyway is the largest implementation of ultra-high performance concrete (UHPC) in North America to date. Approximately 90,000 m<sup>2</sup> (1 million ft<sup>2</sup>) of deck was replaced with precast concrete panels connected with field-placed UHPC, using a total volume of more than 5,000 cubic yards (3,800 cubic meters) of UHPC. The construction of the new deck took place over the course of four years in a temperate climate with hot summers and cold winters. The very large quantity of deck, the large volumes of field-placed UHPC, and multiple years of construction with all possible weather and temperature conditions created challenges to successful UHPC placement.

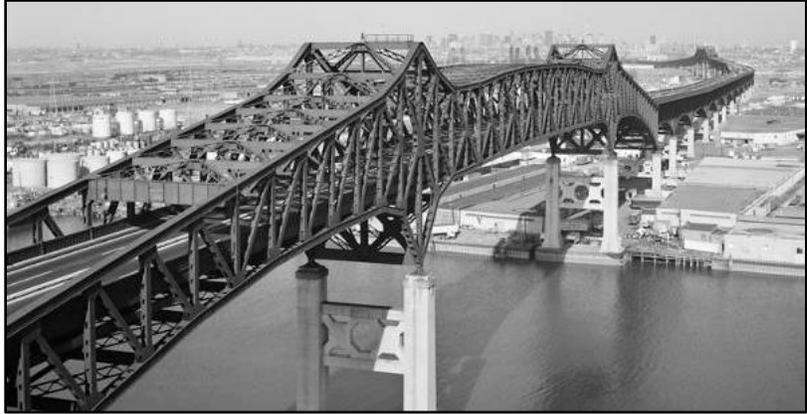
**Figure 1. Partial Elevated View of the Pulaski Skyway**

The Pulaski Skyway is a three and one-half mile (5.6 km) long viaduct located in northern New Jersey that serves as a direct link to New York City via the Holland Tunnel. Between 2014 and 2018, the entire mainline deck of the Pulaski Skyway was replaced. Because the Skyway is such a critical part of the greater New York City transportation network, the New Jersey Department of Transportation (NJDOT) wanted to minimize traffic disruptions during the redecking and design the new deck to eliminate any significant deck maintenance for the next 75 years. Consequently, the NJDOT replaced the majority of the nearly 1 million square feet (93,000 square meters) of deck with precast concrete deck panels connected with ultra-high performance concrete (UHPC). Using UHPC with precast concrete deck panels enabled the project to benefit from the higher quality and faster installation of precast concrete panels compared to a conventional cast-in-place concrete deck, while not sacrificing any durability at the connections as is often seen with conventional connection materials.

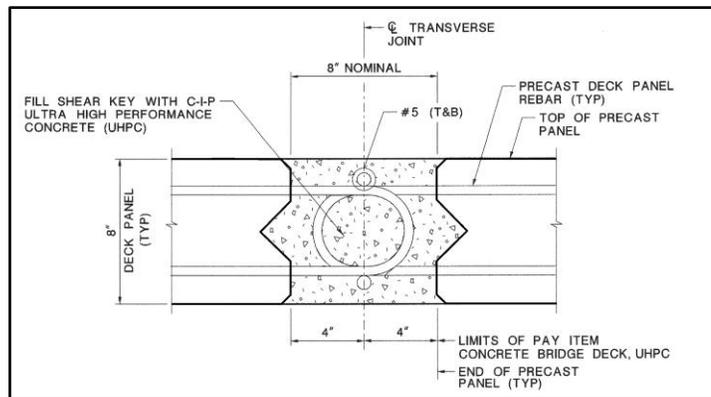
The Pulaski Skyway redecking used UHPC primarily in the following three locations. The first location is the narrow transverse connections between adjacent precast deck panels. The connections between full-depth precast concrete deck panels are 8 inches (200 mm) wide and the connections between the Exodermic deck panels are 10 inches (250 mm) wide.

**Figure 2. Typical Transverse Panel Connection**

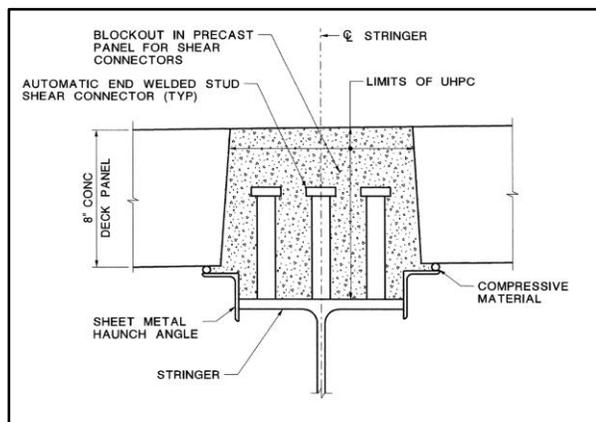
The second location where UHPC was placed is in the deck panel shear connections and haunches that connect the deck panels to the steel framing. Shear studs are welded to the steel framing and extend into the pockets or reserves of the deck panels that are then filled with UHPC. The full-depth precast concrete deck panels had discrete pockets in which shear studs were grouped. The Exodermic deck panels had reserves where the precast concrete was blocked out over the entire length of

**Figure 3. Typical Shear Pocket Detail, As Constructed**

the underlying steel framing, to facilitate shear stud placement which also had to avoid the deck steel grid. Because the shear pockets and reserves are located over the steel framing, the haunches between the bottoms of the deck panels and the tops of the steel framing were poured monolithically with the shear pockets and reserves.

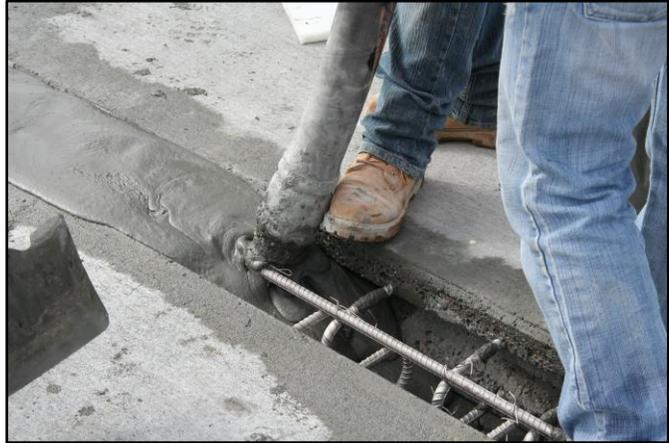
However, when UHPC meeting this specification was put into the pump, the energy imparted by the pump would increase the workability of the UHPC, while the friction of the UHPC passing through the pipe and hose and the exposure of the pipe and hose to the sun increased the temperature of the UHPC, which tends to reduce workability. Thus, it was very difficult to predict the flow of the UHPC out of the pump hose and difficult to know how to adjust the properties of the UHPC coming out of the mixer to compensate. Nonetheless, when the use of a concrete pump began in late fall of 2014, the technician was able to successfully adjust the UHPC properties over multiple batches and pours such that the UHPC exiting the pump hose met the workability criteria for placement.

**Figure 4. UHPC Being Successfully Placed with a Pump in Late Autumn of 2014**

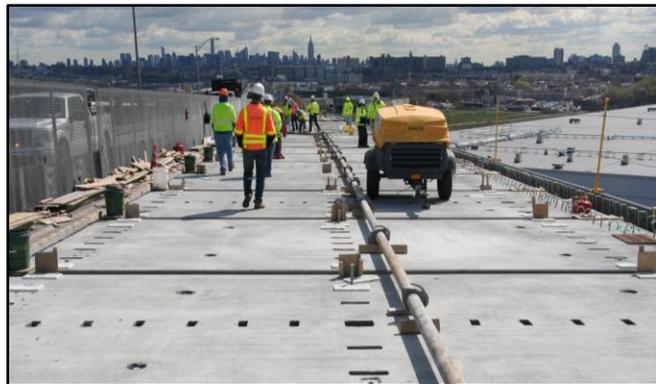
As the following spring arrived, however, the ambient temperatures and the prevalence of sunny days increased, resulting in problems ranging from plugged pumps to voids in the cured UHPC due to a lack of material workability, when the contractor was using over 300 feet of pipe and hose. The solution to the problems caused

**Figure 5. Long Pump Pipe in Spring of 2015**

by pumping was simple – the contractor stopped using a concrete pump and instead started using motorized buggies to transport the fresh UHPC between the mixer and the pour locations. In fact, after temporarily switching to buggies when the NJDOT put a temporary halt on pumping to investigate the situation, it became evident that there was a significant increase in efficiency with no safety issues and the contractor never sought to use the concrete pump again. Solutions for the voids that resulted when the UHPC lost workability due to pumping will be discussed in the section on repair of deficient UHPC pours.

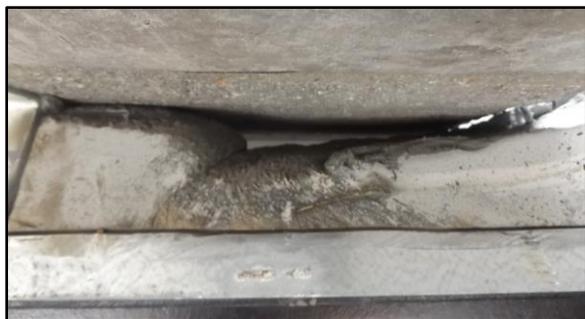
**Figure 6. Partially Removed Form Revealing Underfilled Haunch due to Loss of Workability**

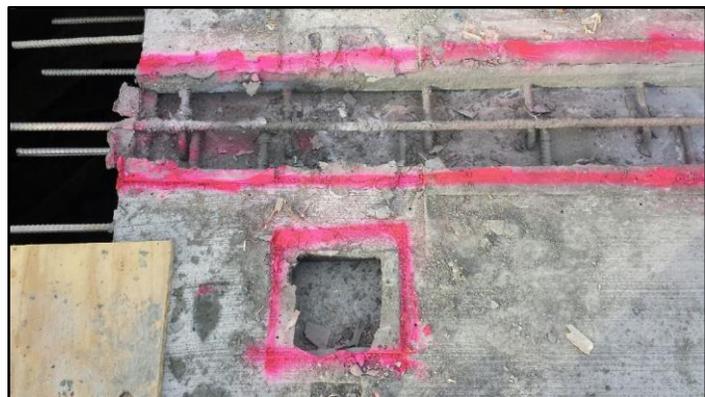
The contractor chose to pour the deck panel connections simultaneously with the haunches and shear connections, leaving them all interconnected. In addition, in attempts to reduce the number of bulkheads, the contractor initially poured the UHPC continuously over many panels, leading to very high head pressures on the downslope formwork. This, in turn, led to a series of leaks and form blowouts.

**Figure 7. Underfilled UHPC Panel Connection and Shear Pocket Due to Leaking Forms**

The solution was to limit the length of UHPC pours on the Pulaski Skyway by limiting the number of panels whose connections and haunches were poured simultaneously, in particular in the areas with higher profile grades. This was accomplished by placing plywood bulkheads at the intersection of the haunches and the transverse panel connections at the limits of the pour. A rule of thumb employed was to limit the number of panels whose haunches and connections were poured simultaneously to three, which spans a bridge length of approximately 75 feet. The repair to underfilled pours will be discussed in the section on repair of deficient UHPC pours.

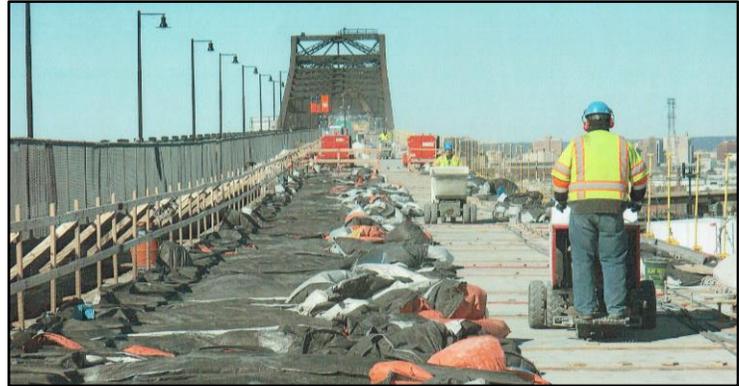
On multiple different occasions, the contractor loaded previously poured UHPC connections before the UHPC had achieved the 14 ksi (96.5 MPa) minimum strength required for loading. The contractor drove motorized buggies across precast deck panels and over their recently poured UHPC connections, by either driving over the top forms or by prematurely removing the top forms. In at least two cases, the UHPC connecting the precast panels had only been poured the previous day. The gross weight of each motorized buggy was similar to the average weight of an automobile but with a much smaller width and wheel base. At least one of those locations was also a cold weather pour with insulating blankets on top that were removed over a width of about 8 feet (2.5 meters). In the case of the cold weather pour, the concerns were not just about early age loading

but also about the minimum temperature not being maintained on the previously poured UHPC in the area where the insulating blankets were removed.

One of the first steps that the NJDOT required was for the contractor to take a 2-inch (50-mm) diameter core from each prematurely loaded connection to check for indications of fiber segregation. A number of those cores showed indications of fiber segregation and some also had cracks.

**Figure 8. Insulating Blankets Removed and UHPC Connections Loaded Prematurely**

These results led to a more rigorous sampling and testing program. NJDOT, in coordination with the design engineers, WSP USA, implemented a program of testing twenty-four 2-inch (50-mm) diameter cores taken from previously cast UHPC deck panel connections that were considered acceptable in order to establish baseline properties. A diameter of 2 inches (50 mm) was used in order to reduce the likelihood of hitting reinforcing steel during the coring operation, and therefore to minimize the damage to the in-place UHPC. The main goals of the testing program were to determine an acceptable tensile capacity of the UHPC and, relatedly, to determine acceptable fiber distribution.

Following the establishment of this criterion, core samples were taken from the UHPC connections that had been loaded prematurely, and they were subjected to the same splitting tensile strength testing as the baseline cores. All of the samples from the prematurely loaded areas had a splitting tensile strength result above the established minimum value with only one exception that was only slightly below the limit. Furthermore, the distribution of the splitting tensile strength values was very similar to that of the baseline samples. While a small number of samples had cracks and apparent fiber segregation, their test results were consistent with the other samples with no reduction in capacity. Consequently, none of the UHPC pours in question were removed.

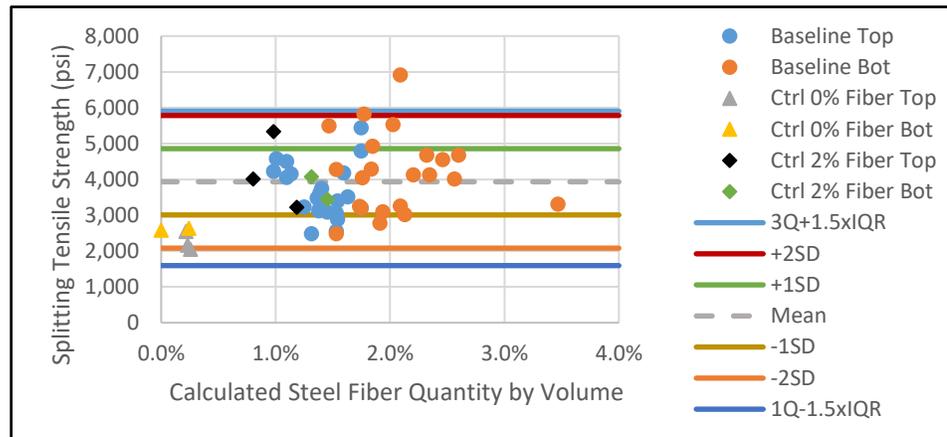
Despite the inability to correlate the test data to direct tension capacity, the baseline samples could still be compared to the control samples with 2% steel fiber. However, even this left some doubt about the results, as three of the 0% fiber control samples had higher test results than three of the half-cores including a bottom half-core sample.

**Figure 9. Calculated Steel Fiber Quantity by Volume vs. Splitting Tensile Strength Test Results of Baseline Samples**

The density of the baseline samples was also calculated as an attempt to quantify fiber content and to identify changes in fiber content due to segregation. This, too, was determined to be an unreliable indicator, as the calculation for steel fiber quantity is highly dependent on the assumed density of the UHPC without steel fiber.

After all of this testing and analysis of baseline samples, it was determined that there were too many uncontrollable or unknown variables and it was impossible to determine actual fiber content or to establish actual tensile capacity of 2-inch (50-mm) diameter UHPC cores. As a result, an acceptance criterion was agreed upon by the NJDOT based on the splitting tensile strength only, using 1.71 standard deviations below the mean as the minimum based on a t-distribution analysis of the 24 baseline samples.

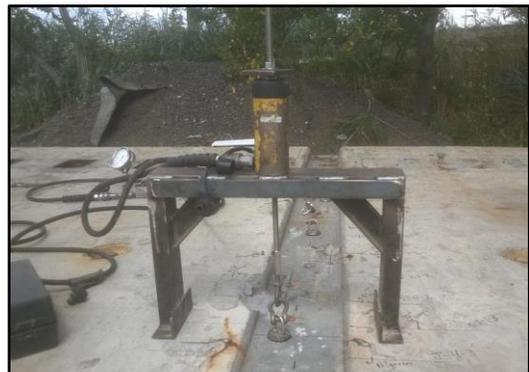
A series of pull-off tests were required in accordance with ASTM C1583, *Standard Test Method for Tensile Strength of Concrete Surfaces and the Bond Strength or Tensile Strength of Concrete Repair and Overlay Materials by Direct Tension (Pull-off Method)*. The NJDOT required a minimum pull-off capacity of 725 psi (5 MPa), based on the direct tension design strength of the UHPC published in the product data sheet, which also includes a mean direct tension strength of 1,160 psi (8 MPa). Unfortunately, none of the pull-off tests met the 725 psi (5 MPa) threshold. As a result, for the entire project, the

Figure 10. Pull-Off Test Setup

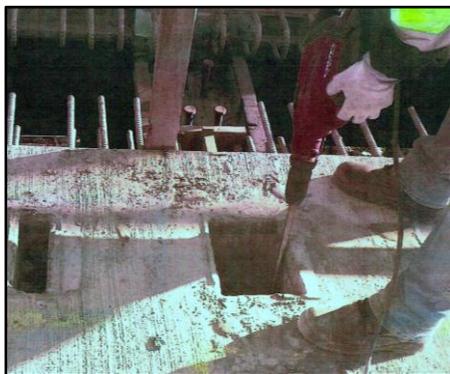
Figure 11. Removing Cured UHPC from Underfilled Shear Pockets

Despite the fact that some of the cured UHPC that needed to be removed was many months old by the time removal efforts began, and thus would have reached the 28-day compressive strength of 22,000 psi (150 MPa) or higher, it was successfully removed with small jackhammers (typically 20 lb [9 kg] maximum size to minimize collateral damage), albeit at a slower pace than what would be expected for removing conventional concrete.

NJDOT disallowed topping off or otherwise repairing any cured UHPC pours that were cast low or that had any voids or other deficiencies, and required that they be completely removed and recast, with a few minor exceptions.
